CARR-1582

**Maryland Historical Trust
State Historic Sites Inventory Form**

historic Lamotte-Bush Farm

street & number 3830 Gamber Road not for publication

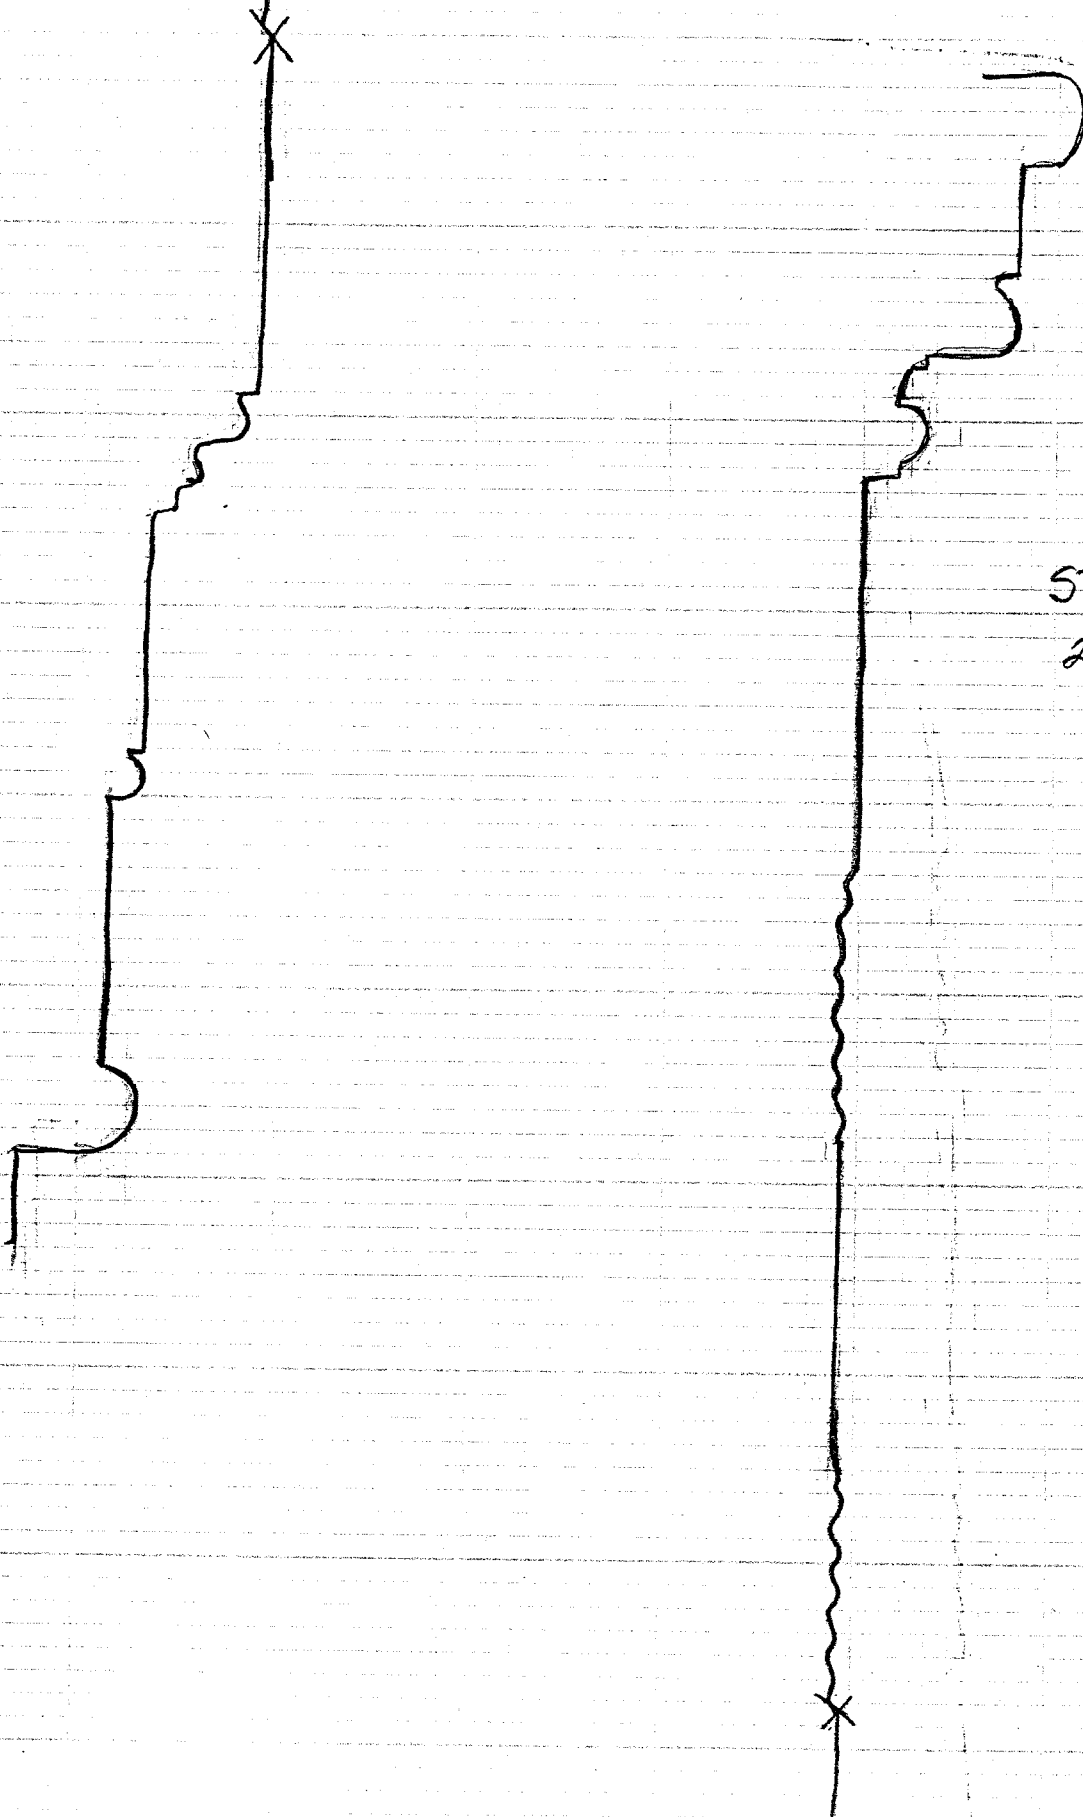
4/4 3830 Gamber Rd.
Moulding Profiles

CHAIR RAIL
WEST ROOM
1 FLOOR

DOOR ARCHITRAVE
1ST FLOOR
STAIR HALL/PASSAGE
LARGE BEAD
NON-HINGE SIDE

DOOR ARCHITRAVE
1ST FLOOR
WEST ROOM
SMALL BEAD
HINGE SIDE

STAIR STRINGER
2 SECTIONS

The first story is laid out on a side passage, single pile plan. The passage has a random-width floor that runs northeast to southwest. There is a chair-rail and the architrave has quirked steep ogee-and-bead backband and a beaded interior edge. There is a vertical-sawn lath and plaster. A two-flight stair runs up along the northeast wall. It has a closed stringer with two sets of five wreaths and a quirked steep ogee-and-bead at both the top and bottom. The balusters are rectangular and there's a $\frac{3}{4}$ round handrail that is mortised and tenoned and pegged to a thin slightly tapered turned knulepost. There is a landing on the northwest end, then stairway turns to the southeast. Beneath the stairway are beaded-edge vertical boards and a closet with all new trim. The rear or northwest door has been completely altered.

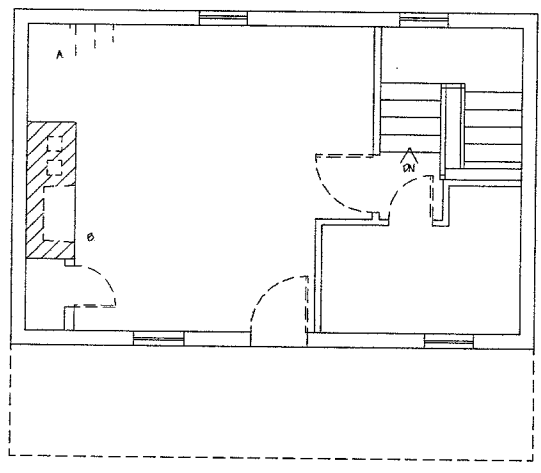
CARR- 1582	LAMOTTE - BUSH FARM	MEASURED BY KEN SHORT AND BARB LILLY	THIRD FLOOR PLAN

- A. GHOSTS OF ORIGINAL WINDER STAIR TO ATTIC.
- B. FIREPLACE CLOSED OFF.
- C. PORCH DECK DEMOLISHED. APPROXIMATE DIMENSIONS TAKEN FROM ORIGINAL SURVIVING ROOF.

The third story landing in the middle of the stairs has sawn vertical lath on the logs. The logs beneath are heavily whitewashed. The window opening on the landing has the same chair-rail and architrave. There is sawn lath on the ceiling. The top landing on the third floor has a doorway both to the southeast and the southwest. These doorways have typical architrave. There is a summer beam in the floor that runs northeast to southwest and acts as a stair header as well. It is hewn and is $3\frac{1}{2}$ " x $7\frac{1}{2}$ ". The joists are the same size as the summer beam and are also hewn. They have a center tenon into the mortise in the summer beam that is pegged. The third floor has a two-room plan. The east chamber is L-shaped and extends partly above the lower flight of stairs. It has typical architrave and chair-rail, though there is no chair-rail on the southwest wall and part of the northwest wall.

The southwest chamber has a doorway on the southeast that has the typical architrave and appears to be in original configuration. This doorway must have led to the third floor of the porch. It has heavily painted cast iron butt hinges fastened with blunt-tipped screws. There is a chimney stack centered on the south elevation and a built-in closet south of it. The closet is constructed with wire nails. There are ghosts along the northwest and northeast elevations of chair-rail that appears to have been removed. This is not a recent alteration. In the west corner are clear ghosts indicating the location of a winder stair to the attic that was removed. This too does not appear to have been a recent alteration. There is an opening in the ceiling of the west corner of this chamber that gives access to the attic now.

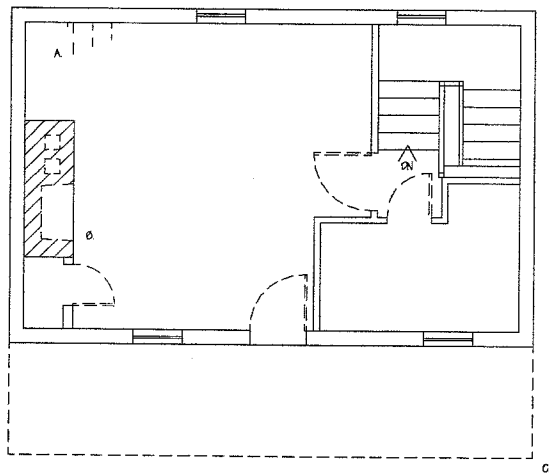
THIRD FLOOR PLAN

NOTES
 A. GHOSTS OF ORIGINAL WINDOW STAIR TO ATTIC.
 B. FIREPLACE CLOSED OFF.
 C. PORCH DECK DEMOLISHED. APPROXIMATE DIMENSIONS TAKEN FROM ORIGINAL SURVIVING ROOF.

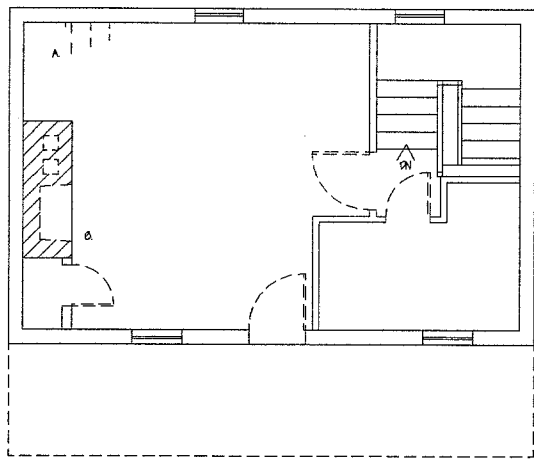
THIRD FLOOR PLAN

- A. GHOSTS OF ORIGINAL WINDOW STAIR TO ATTIC.
- B. FIREPLACE CLOSED OFF.
- C. PORCH DECK DEMOLISHED. APPROXIMATE DIMENSIONS TAKEN FROM ORIGINAL SURVIVING ROOM.

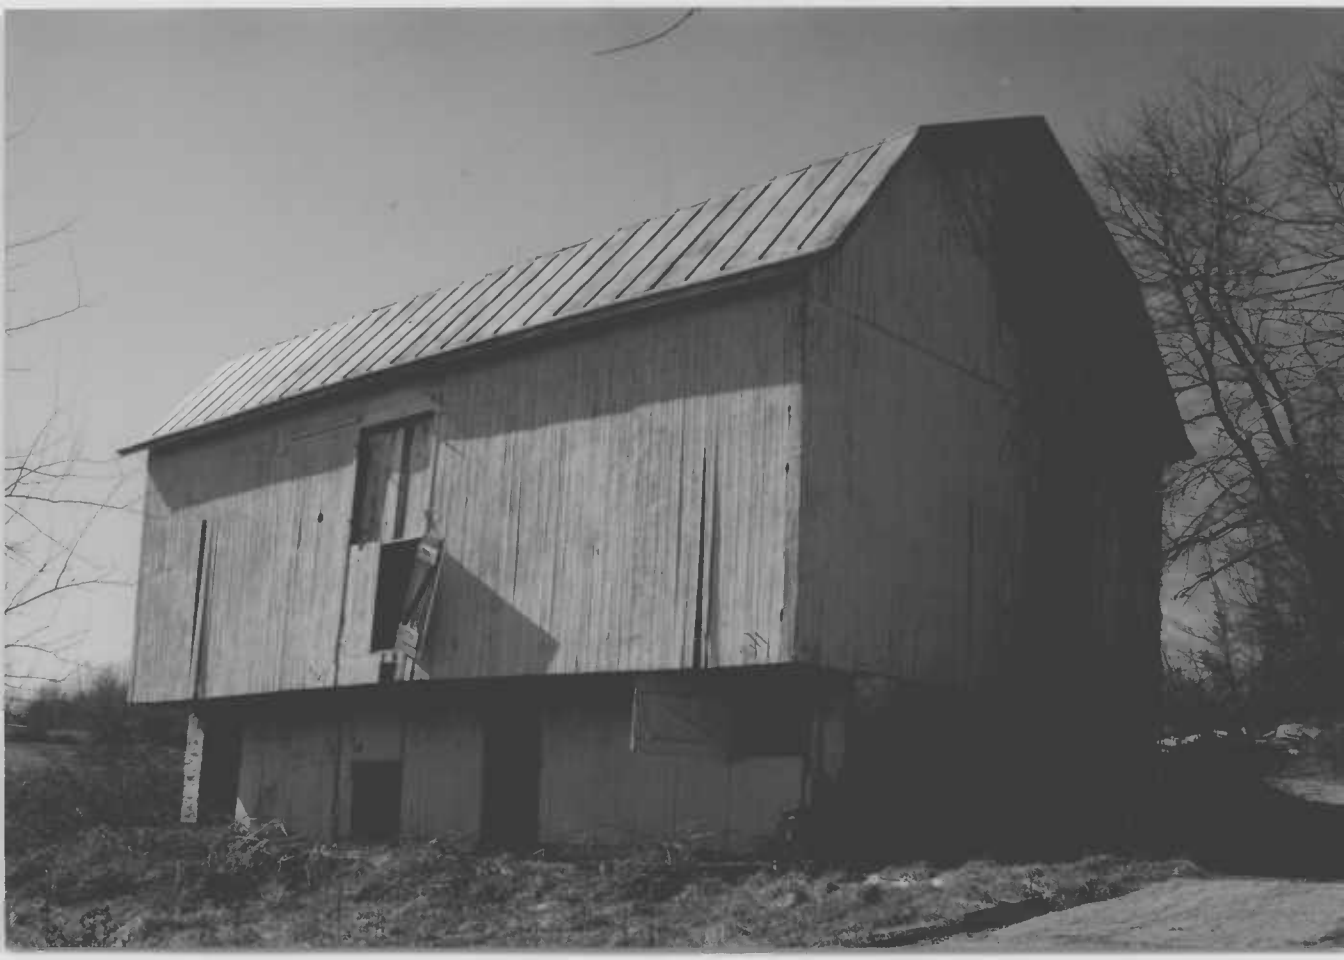
10F7

Barn: SE & NE Elevation

There is a bank barn about 80' west of the log house, the forebay faces southeast, it has a rubble stone lower story on three sides with beaded-edge-in-center vertical boards on the southeast elevation of the lower story and on the upper story. There is a gambrel roof with standing seam metal and northeast to southwest ridges. The southeast elevation on the lower story has a concrete sill, there are five Dutch doors that match the siding. The doors are hung on machine cut strap hinges, the upper story has center double vertical board doors set above a second set of double vertical board doors. These doors were originally hung on rollers.

On the southwest elevation the lower story has two openings with circular sawn frames, the upper story has a tripartite vent in the gable end. On the northwest elevation, the upper story has a new pair of plywood wagon doors on rollers. On the northeast elevation, the lower story has a wide opening set to the east, half of which is closed off and the other half of which has a beaded-edge-in-center

vertical board door. To the north is a window opening. The upper story has a tripartite vent in the gable end like that on the southwest elevation.

The lower story joists are circular sawn on top and bottom and span the whole width of the barn, they are supported by a single summer beam that is circular sawn and has five posts beneath it. The southeast wall is a frame wall, the upper story has a center threshing floor with a Hamill on each end and a granary on the northwest, north of the threshing floor. This granary does not extend all the way to the northeast elevation. The barn has four circular sawn morticed and tenoned and pegged framed bents, each bents has four posts, however the two center posts do not extend to the roof. There is a single Gert, the gambrel roof is supported by posts set on top of the Gert, these posts are set between the end posts and the center posts, right under the gambrel ridge. The rafters are approximately 2x4's and there is a hay track in the ridge. The siding is all fastened with wire nails.

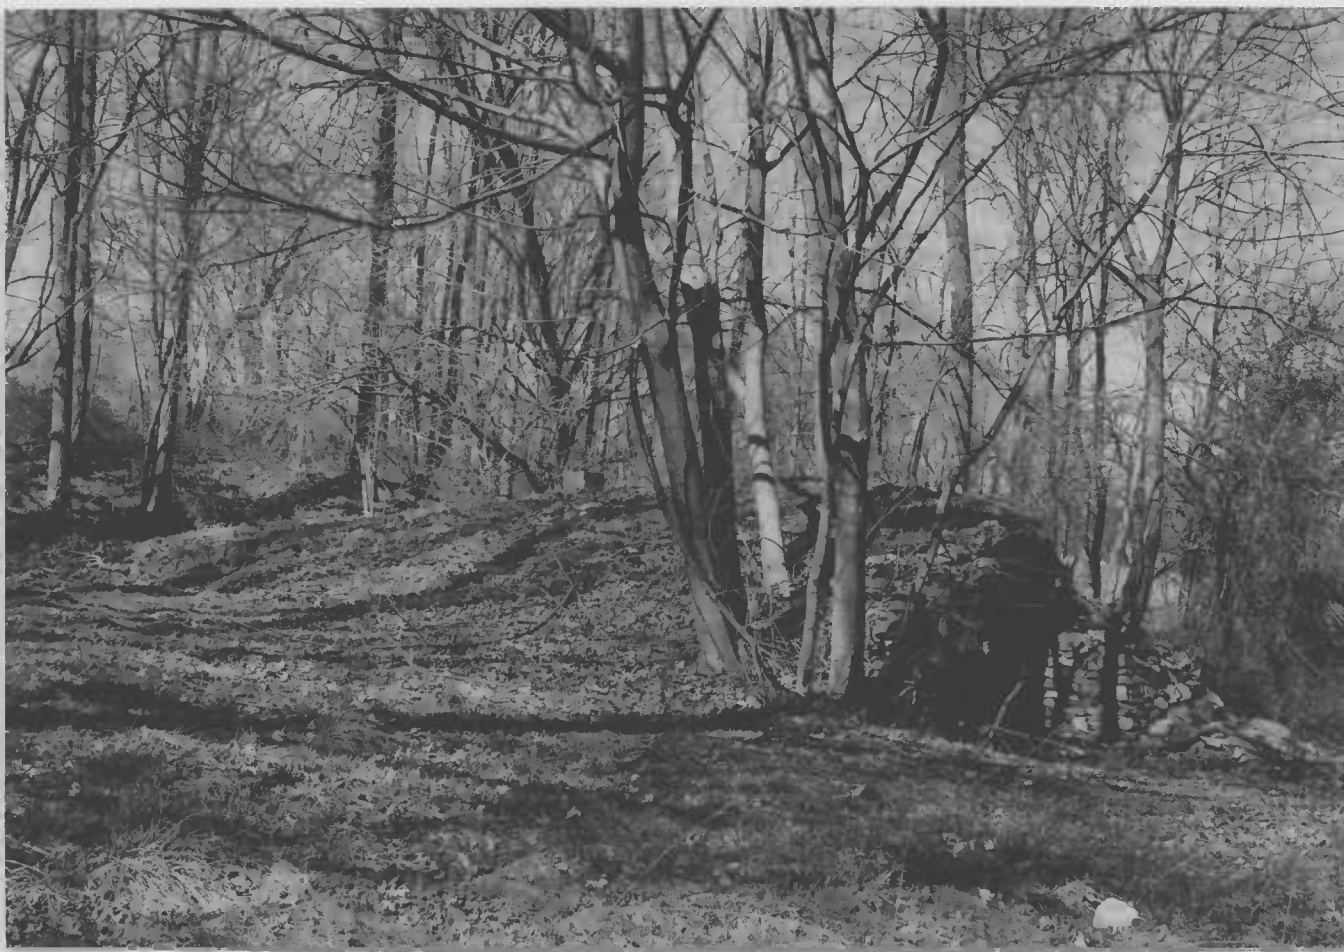
20F7

Neg. Loc.: Maryland Historical Trust
Cave Cellar View from South

About 30' east of the house is a cave cellar that faces southeast and is banked into the hill slightly and the ground raised up over top of the cellar. It is of rubble stone and has been repointed. The southeast elevation is arched and has projecting dry-laid rubble stone buttresses at the east and south corners. The east buttress is partially collapsed. There is a doorway in the center that has been altered and has a metal lintel. The stone above appears to be rebuilt. There is a concrete vent above ground to the rear of the cave cellar. The interior is barrel vaulted and is all of stone with a narrow ledge on either side of the barrel vault where it meets the walls. There are traces of plaster on the stone. The floor is dirt and there is a vent hole in the ceiling the northwest end.

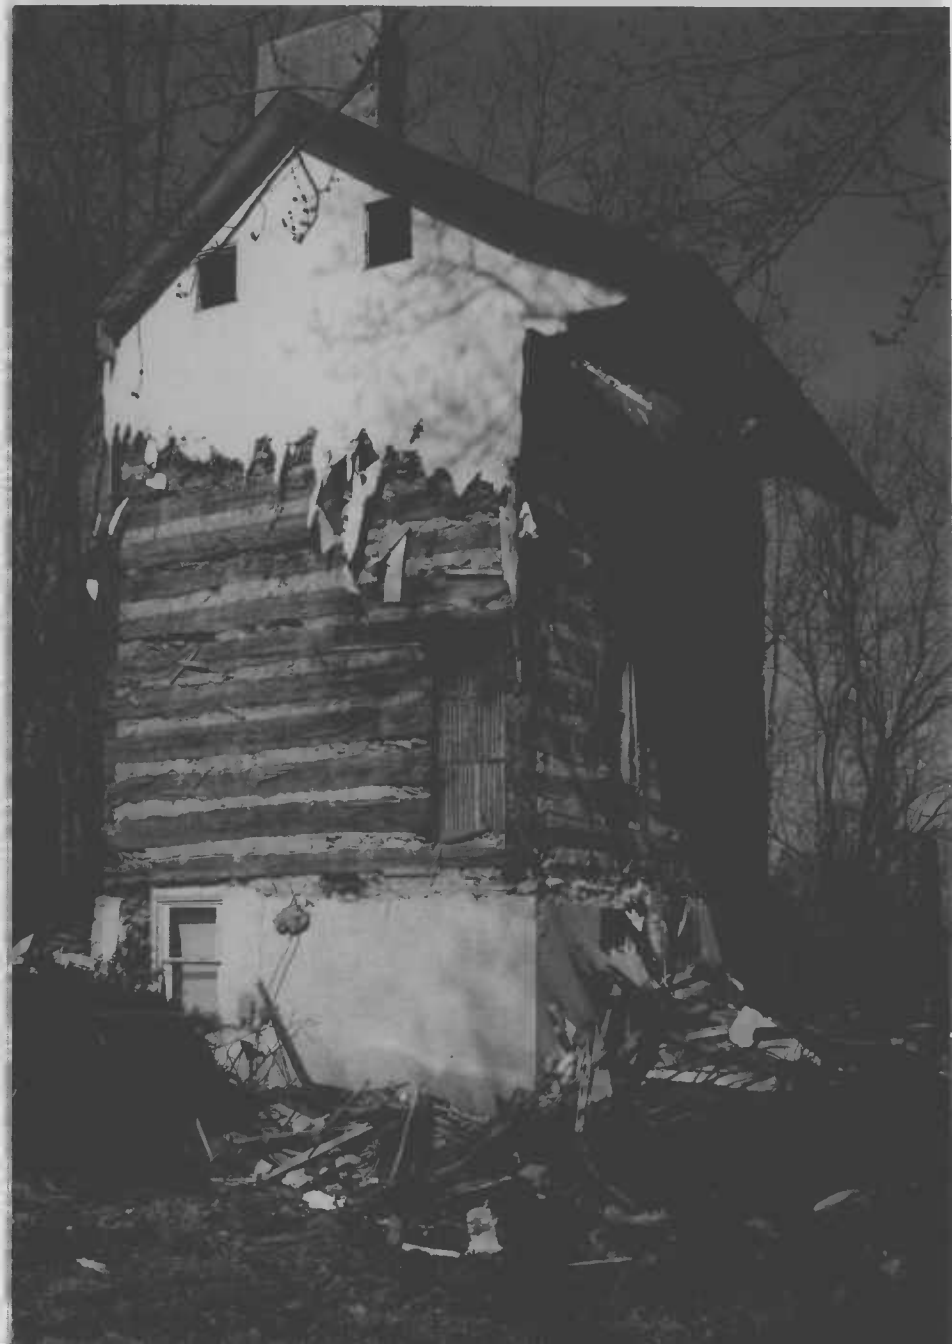
3 OF 7

Neg. Loc.: Maryland Historical Trust
House - SW & SE Elevations

The house faces southeast toward the road and is a three-story three-bay-by-two-bay log structure with a rubble stone lower story that is stuccoed and v-notch corner logs on the second and third stories. There is a gable-roof of standing-seam metal on the southeast elevation with asphalt shingles on the northwest elevation. The ridge runs northeast to southwest. There is an interior parged chimney on the southwest gable end. The structure is similar to many banked log structures but is not banked even though the sight slopes down from the northwest to the southeast. The lower story or foundation is exposed on all four sides. On the southeast elevation, the first story has a center door that is new. It is flanked on either side by a one-over-one sash with wide beaded interior-edge frames and no back band. The floor joists for the second-story floor appear either to be sawed off or roughly broken off. It would appear that every other floor joist projected to support a floor for a porch on the southeast. Possibly all of the joists projected. On the second story, the south and center bays have one-over-one sash with portions of architrave that have a beaded-interior-edge, but the back bands are gone. The doorway in the east bay is original but has been closed off to make a window. The jam boards are sawn and are approximately 2x8's and are pegged to the log ends. The logs are whitewashed. Every other one of the third story floor joists projected. Most of these are now broken off. The end logs at the same level also projected to support a porch floor at the third story. The third story has a center doorway that is flanked by a one-over-one sash on each side with the same architraves as seen on the second story. The attic joists project about 10 inches, and the roof rafters project and align with these joists. The rafters overhang to provide roofing for the front porch.

The southwest elevation on the first story has a one-over-one sash in the west bay with the same frame as found on the first story of the southeast elevation. The second story has a doorway at the south corner that has been lathed and plastered over on the interior with vertical circular-sawn lath. The jam boards for this door opening are about one inch thick, are circular sawn and are nailed to the log ends suggesting that the doorway is a later alteration. The third story has no openings. The gable end has two small openings. Most of the siding has been removed, but there is some stucco on top of circular-sawn weather boards. There is no trace of whitewash on the logs. The house had box cornices with no returns.

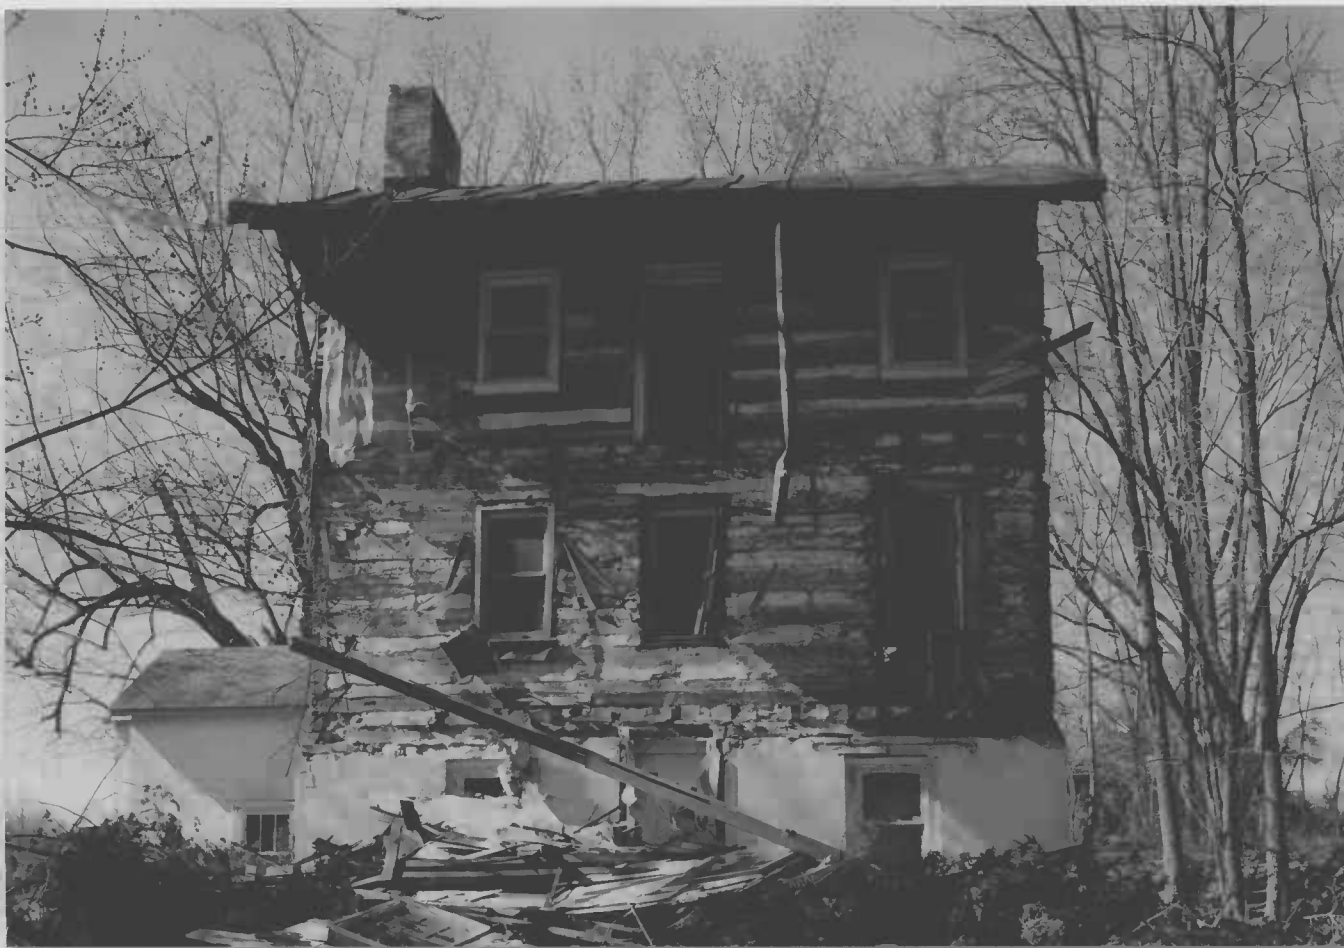
4 OF 7

Neg. Loc: Maryland Historical Trust
House - SE Elevation

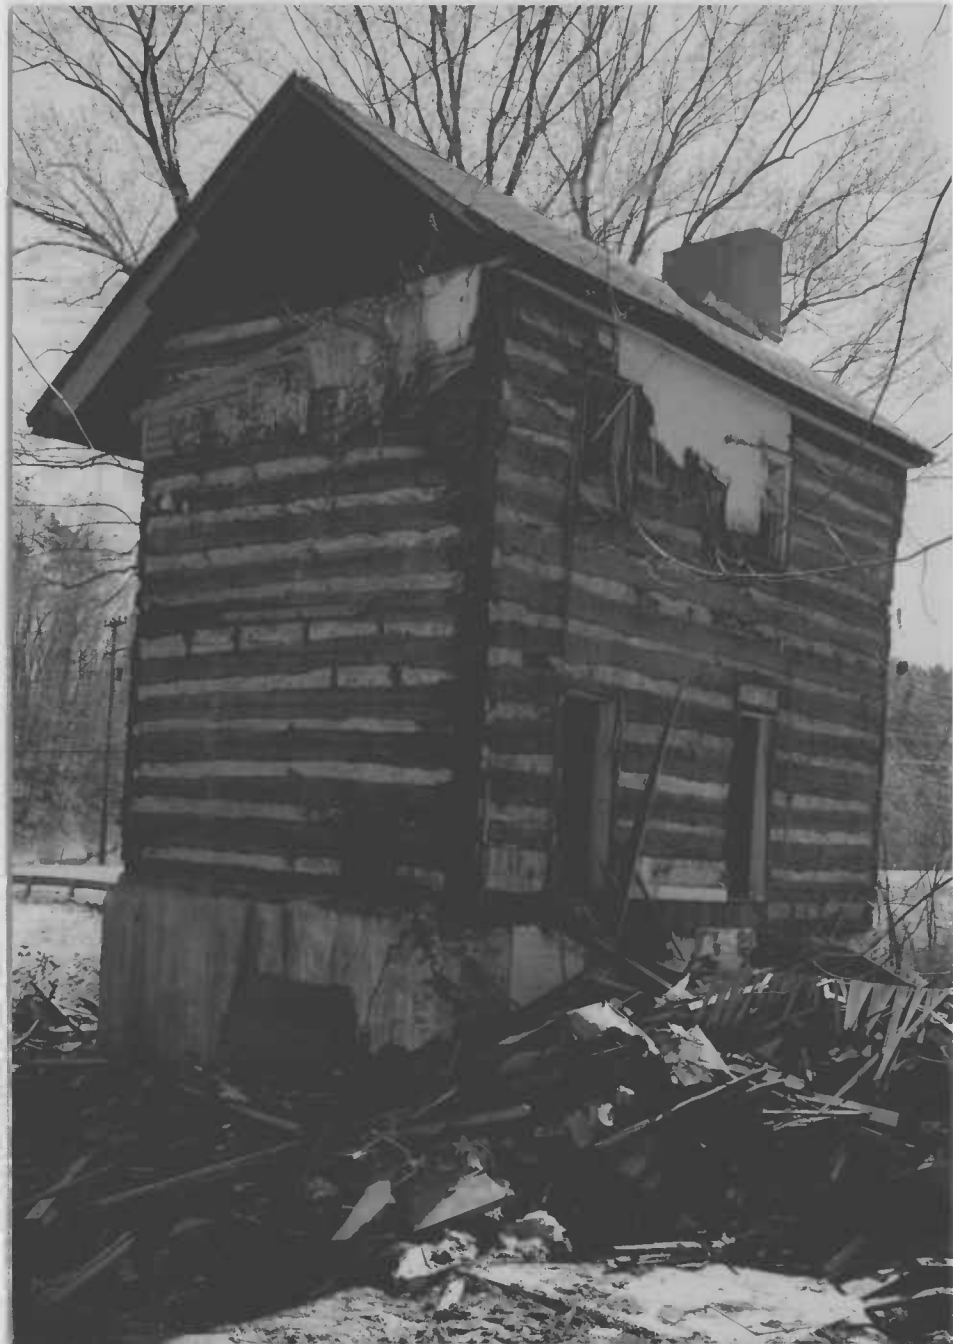
5 OF 7

House - NW & NE Elevations

The northwest elevation has two bays. The first story has had a partial wall collapse of the stone in the north bay. There may have been an original or later opening here, but it no longer possible to determine for sure. It appears there was an original opening in the west bay that was later

probably widened as the jams now have beaded-edge-in-center vertical boards. On the second story, the north bay has a doorway with jam boards that approximately 2 inches thick. The west bay was originally a window opening with 2 inch thick jams. This opening has been converted into a doorway as there was an addition on the northwest elevation. This addition has been demolished. The joists on the second and third stories never projected on this elevation. The chinking between the logs is diagonally laid stone. The third story has two one-over-one sash. These are original openings but appears that the architraves were removed when the building was stuccoed. There is a wood box cornice on this elevation.

On the northeast elevation, the first story is stuccoed and has no openings. The second story north bay has a small window opening with 2 inch thick jams. The opening is 24" high by 20" wide. There are four wood nailing blocks set between the logs two logs below the third floor level, and there are two wood nailing blocks below them in the north bay. The purpose of these is not known. The third story has no openings. Again, there are no traces of whitewash, and the siding has stucco over circular-sawn weather boards.

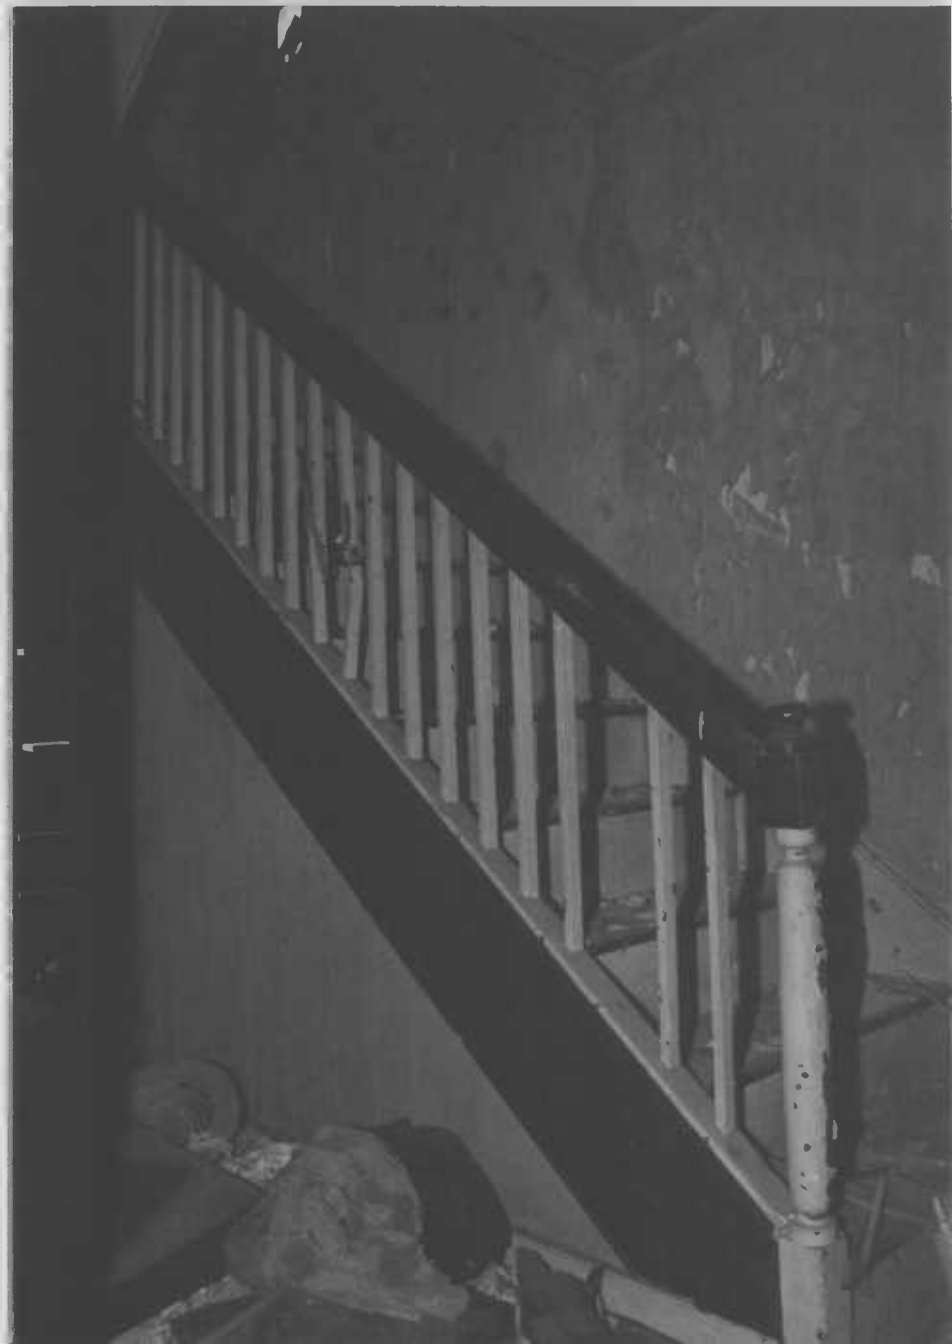
6 OF 7

HOUSE STAIRWAY V.W. N. - SECOND STORY

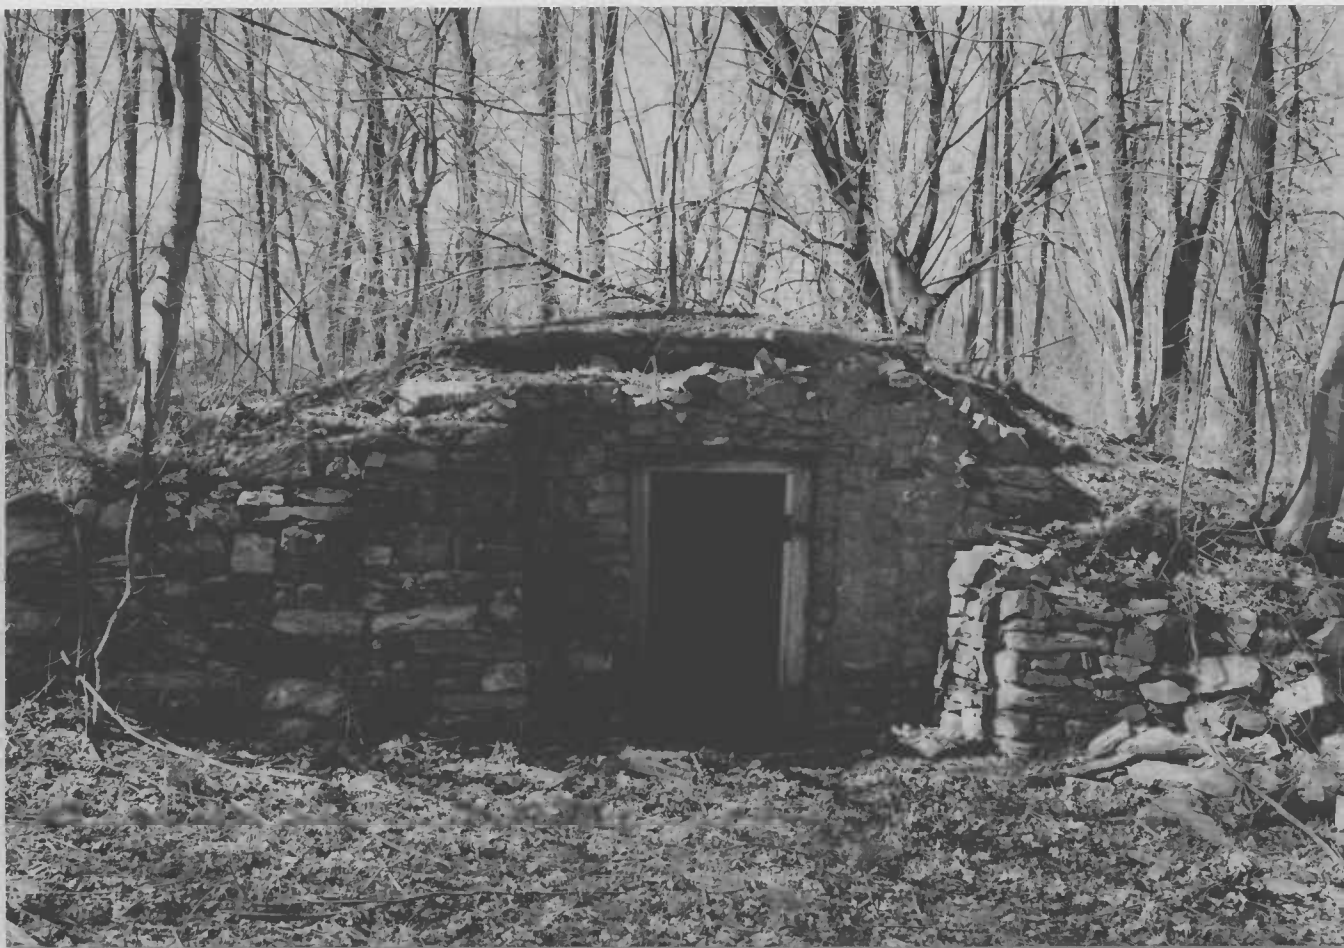
70F7

Neg. Loc: Maryland Historical Trust
Cave Cellar - SE Elevation
